Farms and Fuel Storage Tanks

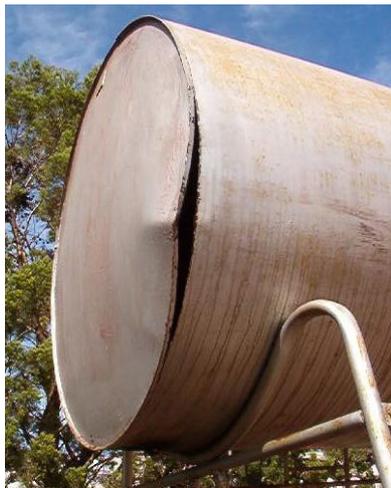
Ruptured Tank

When tank failures like these occur, the environmental impact can be severe. Clean up costs are often significant, and damage to creeks, watercourses, and land can result in substantial EPA fines for landowners. In most cases, failures are due to partially blocked tank venting or vents that do not meet the minimum diameter required by AS1940-2017.

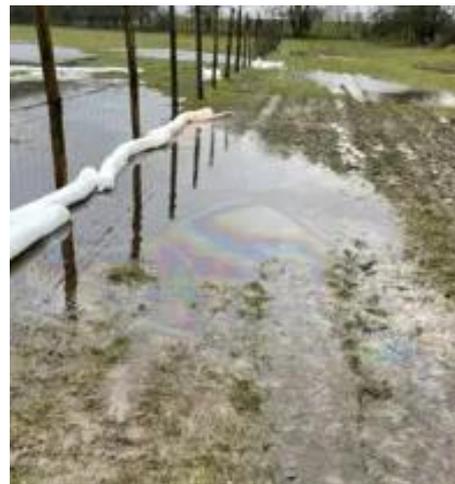
Extent of Spill

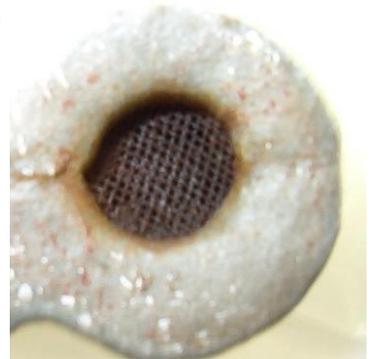
Inspect the tank vent. If it looks like the one shown below—partially or completely blocked.

The vent shown here, a dual down-draft type, is at least 50% blocked. As fuel is dispensed into the tank, restricted vapour escape causes pressurization. Excessive pressure from inadequate ventilation can lead to tank rupture. The vent should be either removed and cleaned or fully replaced—at a total cost of less than \$20 and just 15 minutes of your time. A small price to pay for preventing major damage.
